1N-23
3802
NASA Contractor Report 4586

Analysis of Selected Materials Flown on Interior Locations of the Long Duration Exposure Facility

H. A. Smith, K. M. Nelson, D. Eash, and H. G. Pippin

Contracts NAS1-18224 and NAS1-19247
Prepared for Langley Research Center

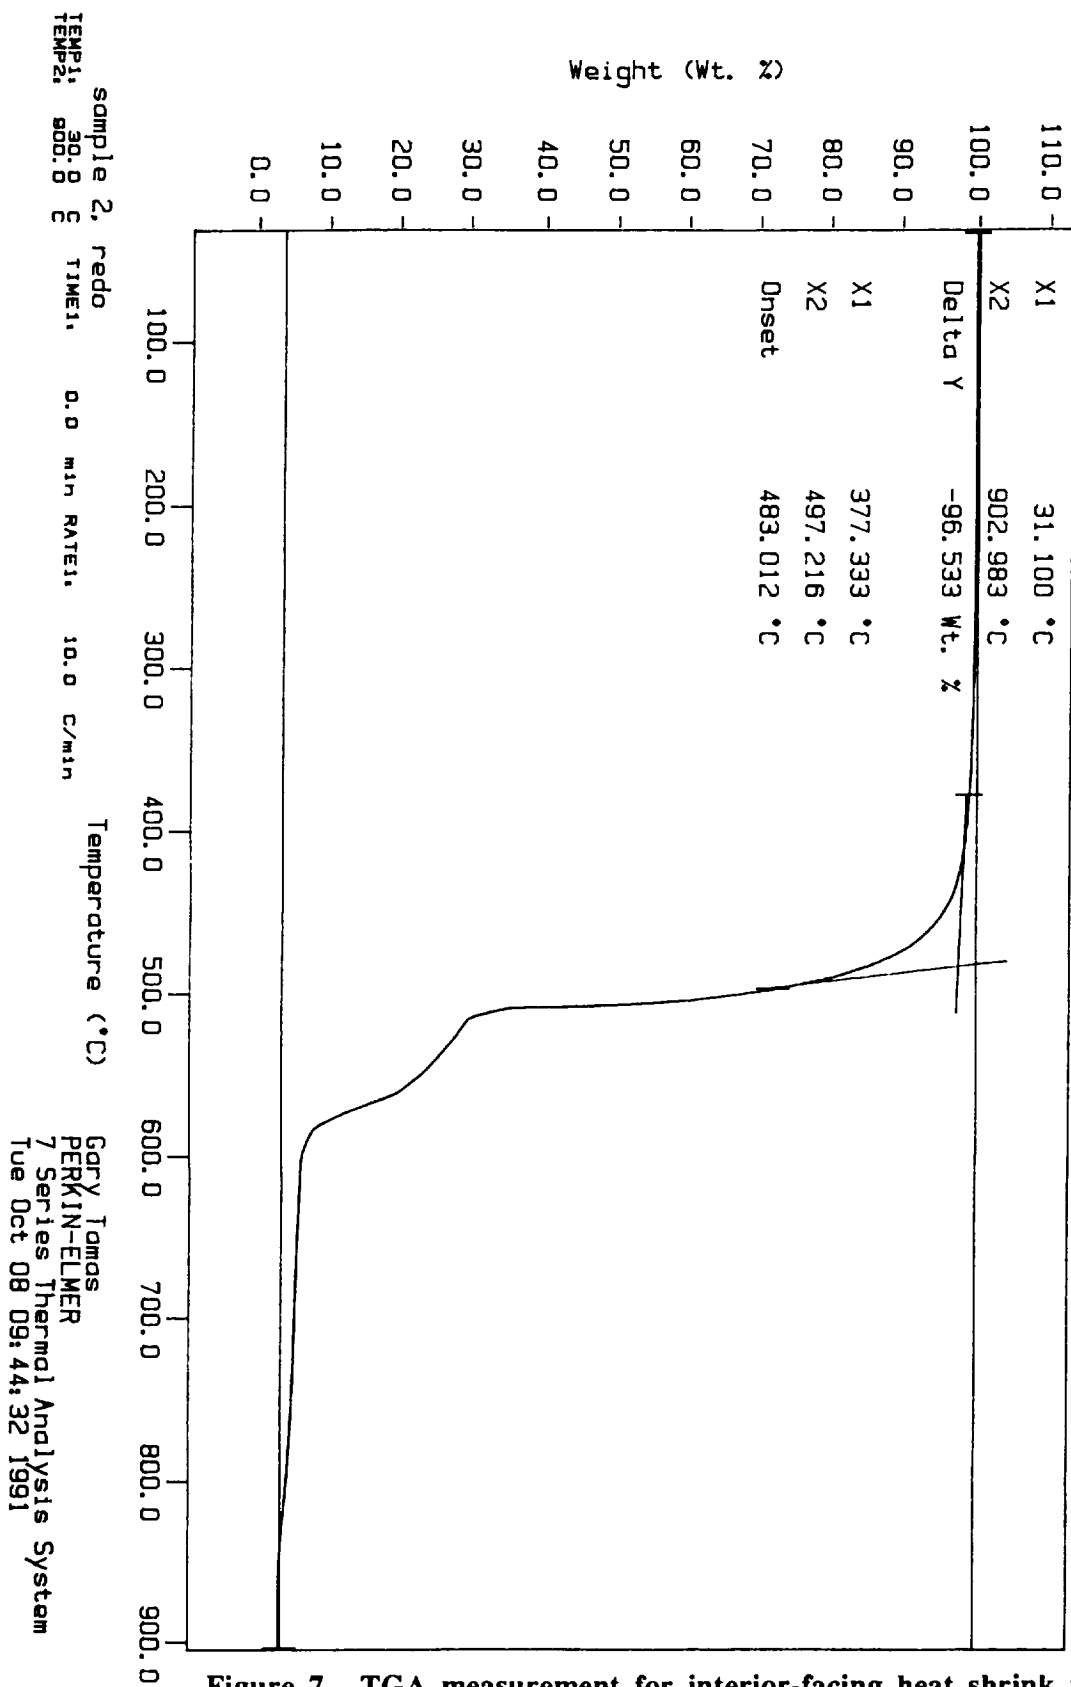
Figure 7. TGA measurement for interior-facing heat shrink tubing specimen J6.

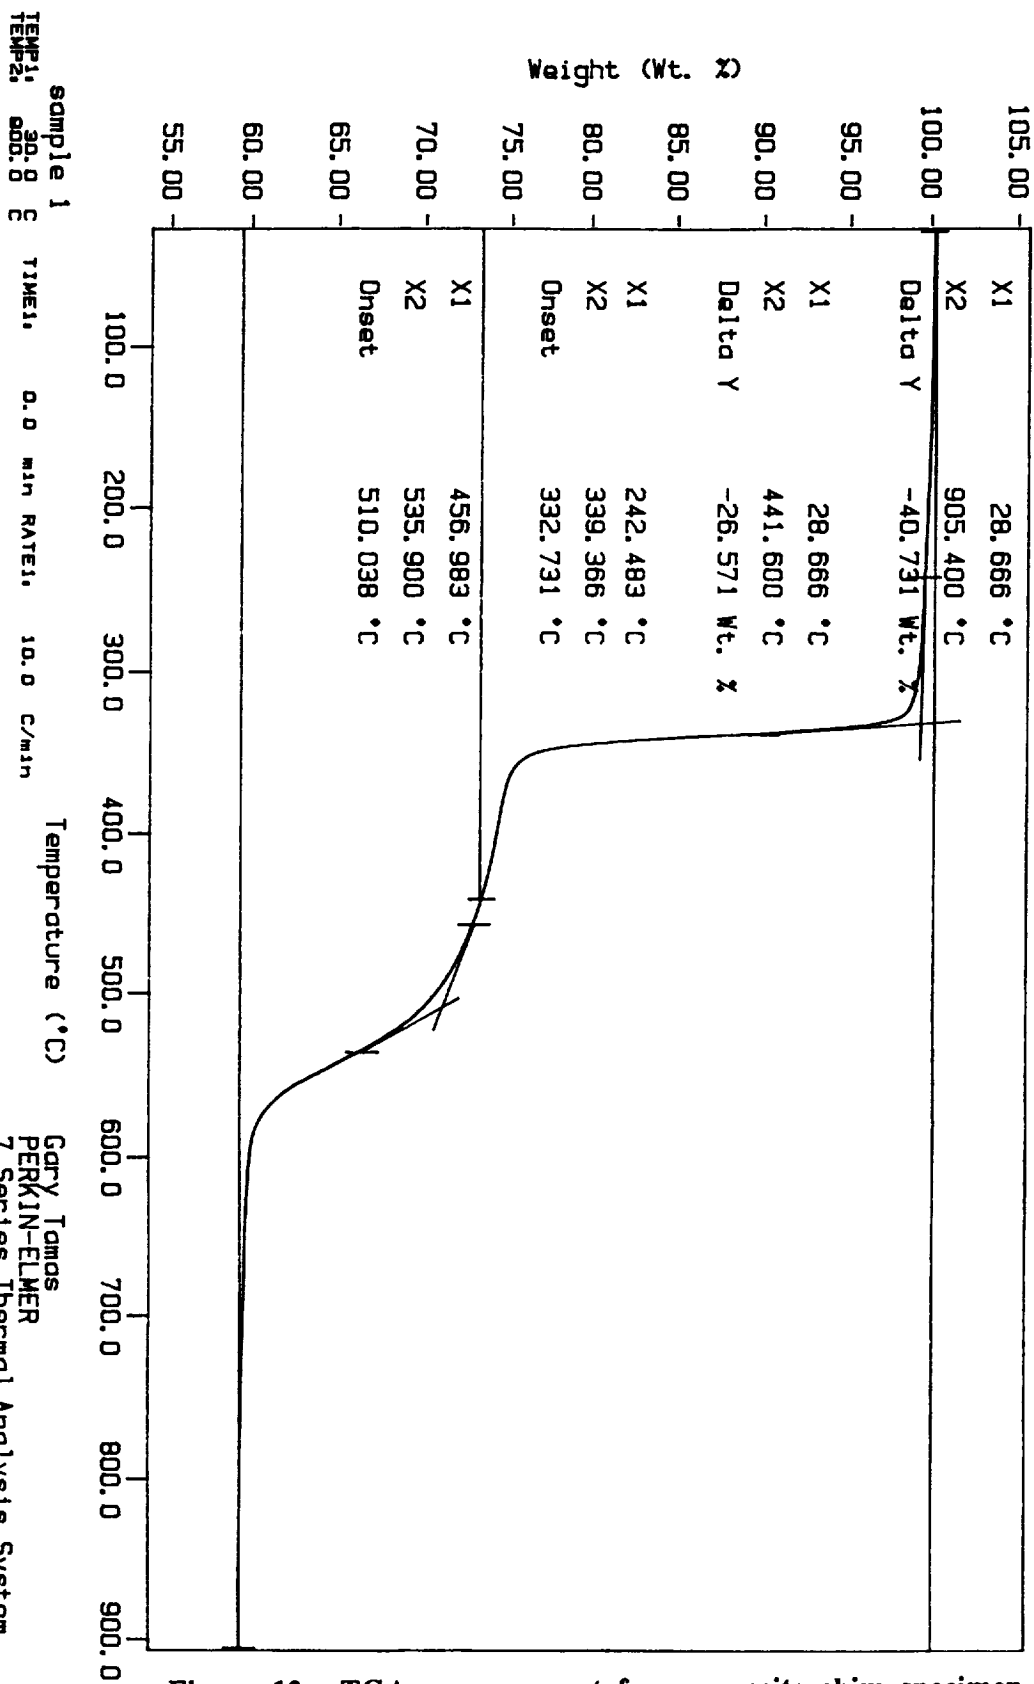
Figure 12. TGA measurement for composite shim specimen D3.

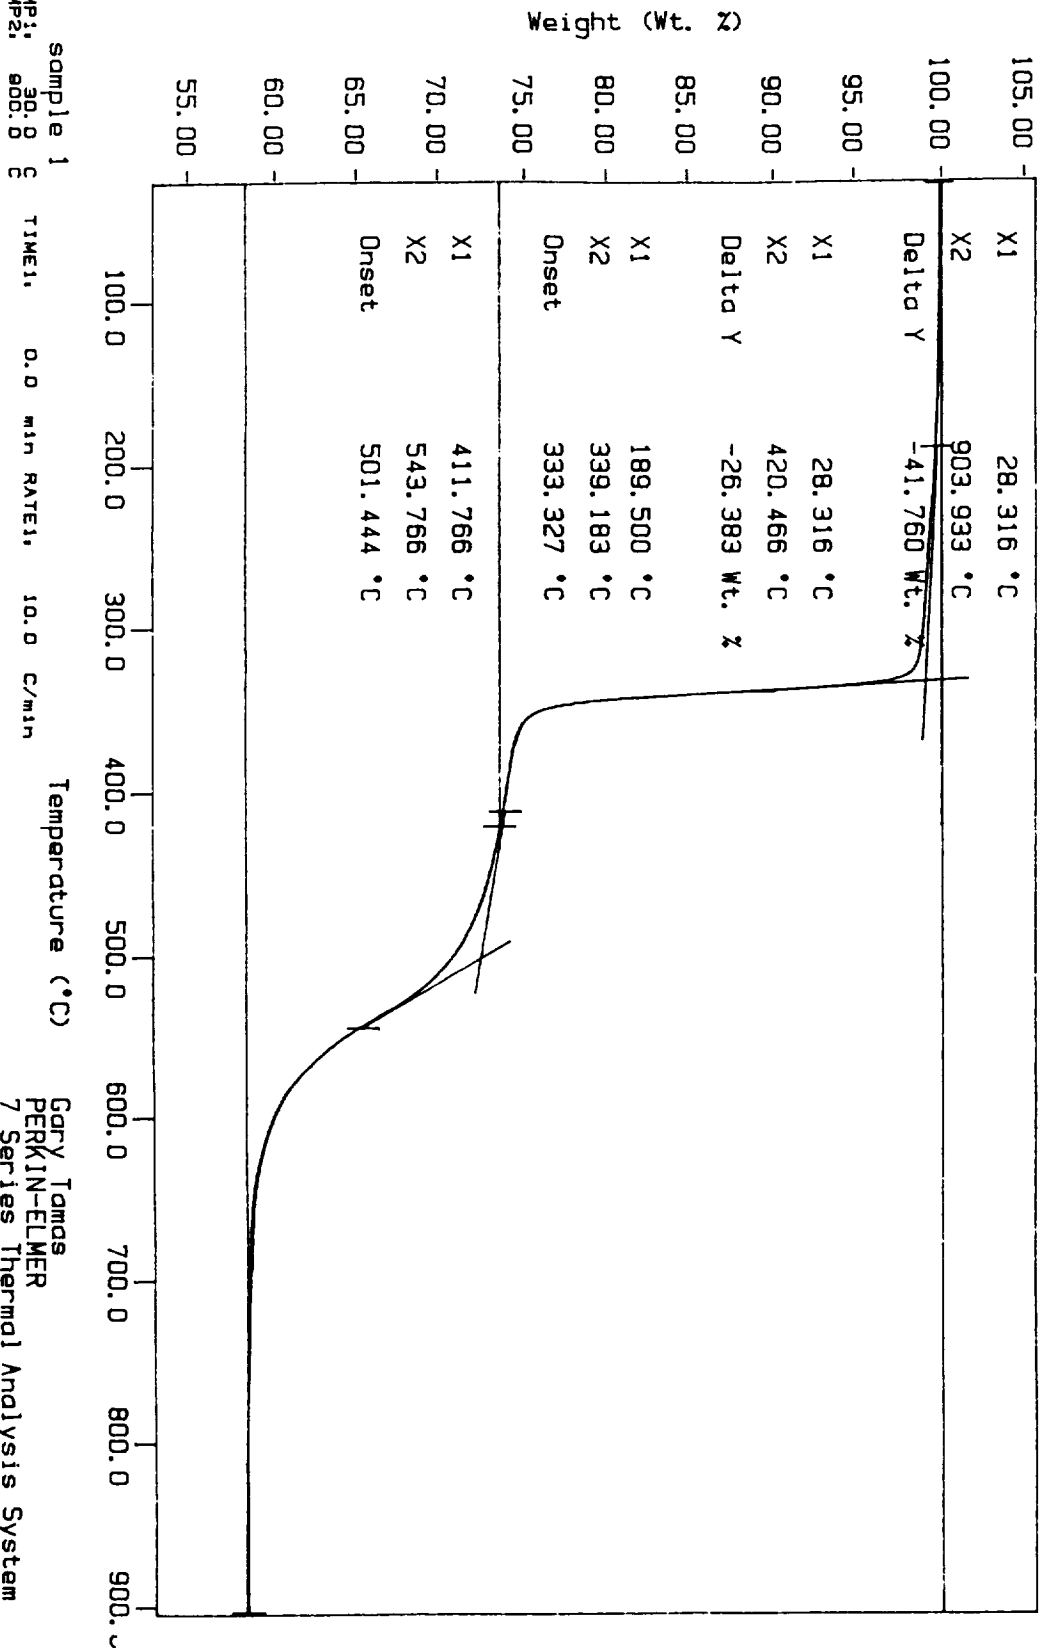
Figure 13. TGA measurement for composite shim specimen J6.

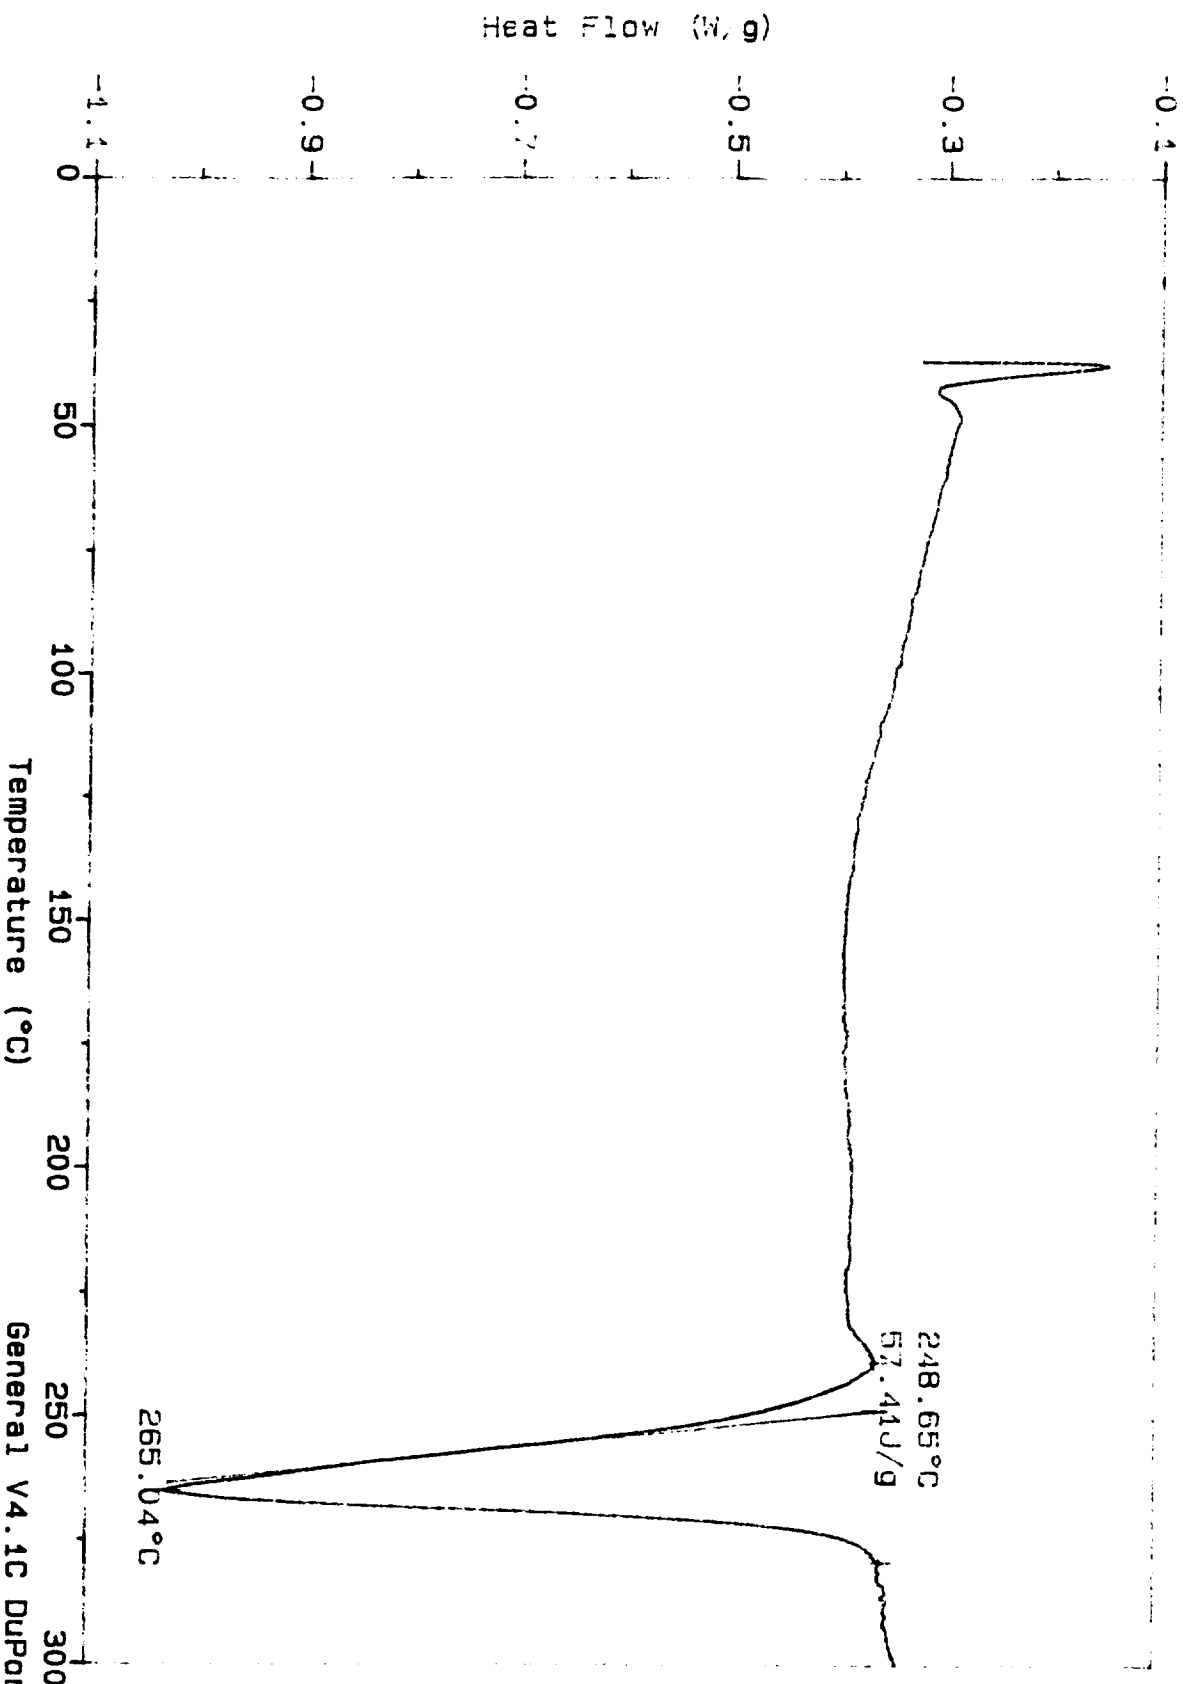
Figure 15. DSC measurement on wire harness bundle nylon grommet F3.

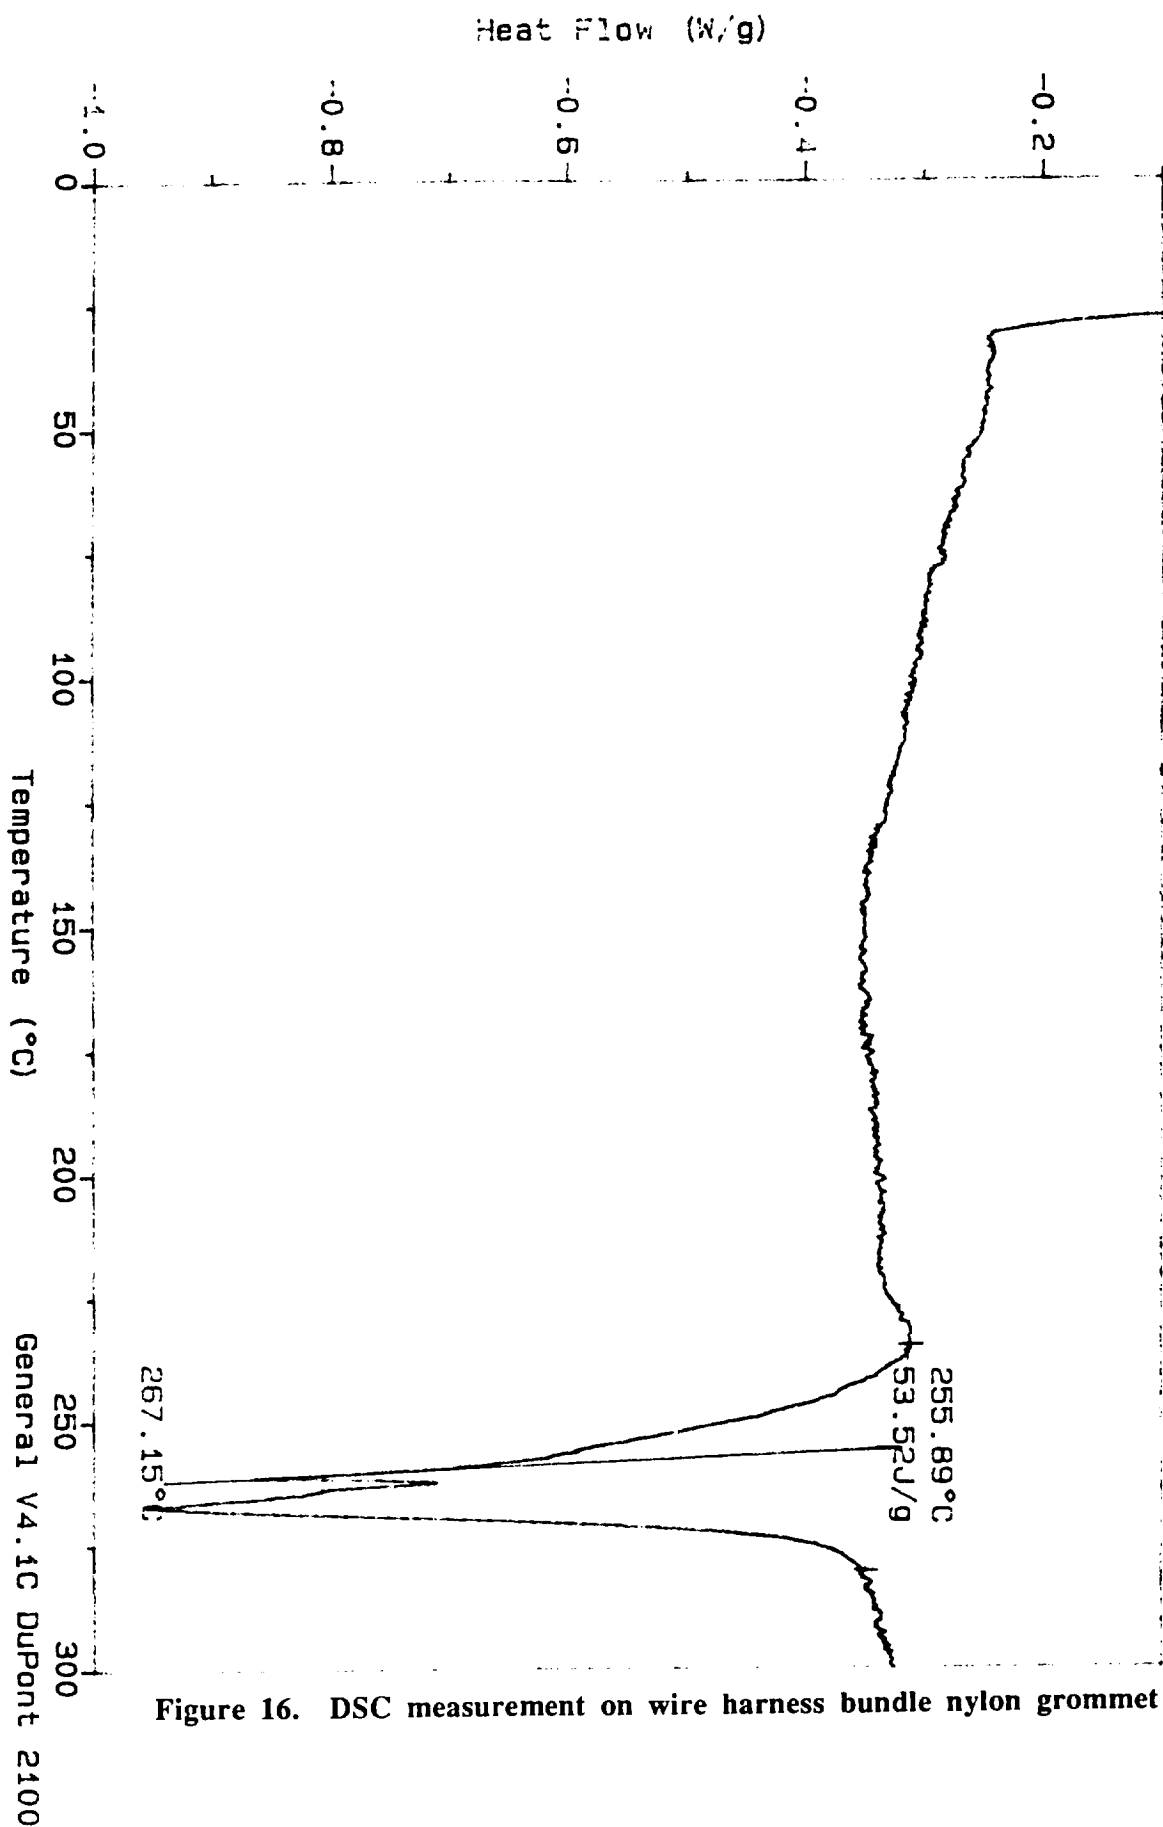
Figure 16. DSC measurement on wire harness bundle nylon grommet H4.

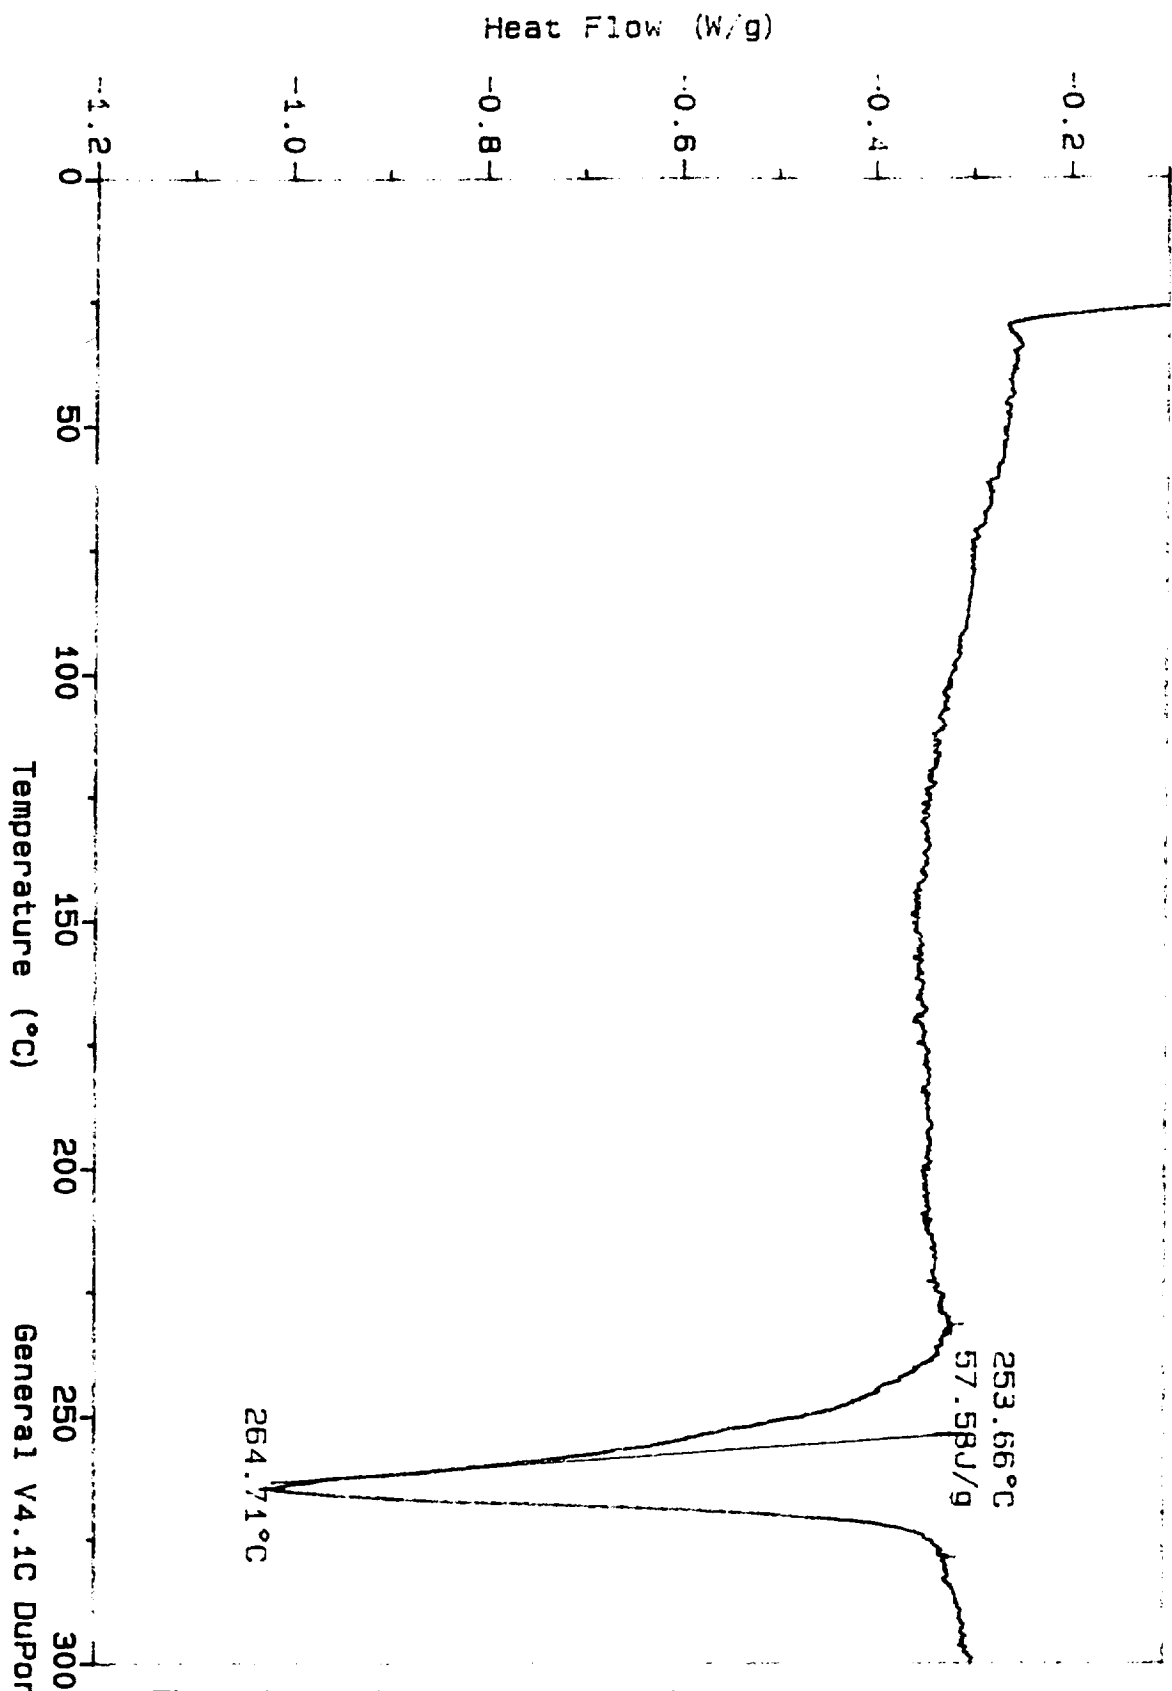
Figure 17. DSC measurement on wire harness bundle nylon grommet I2.

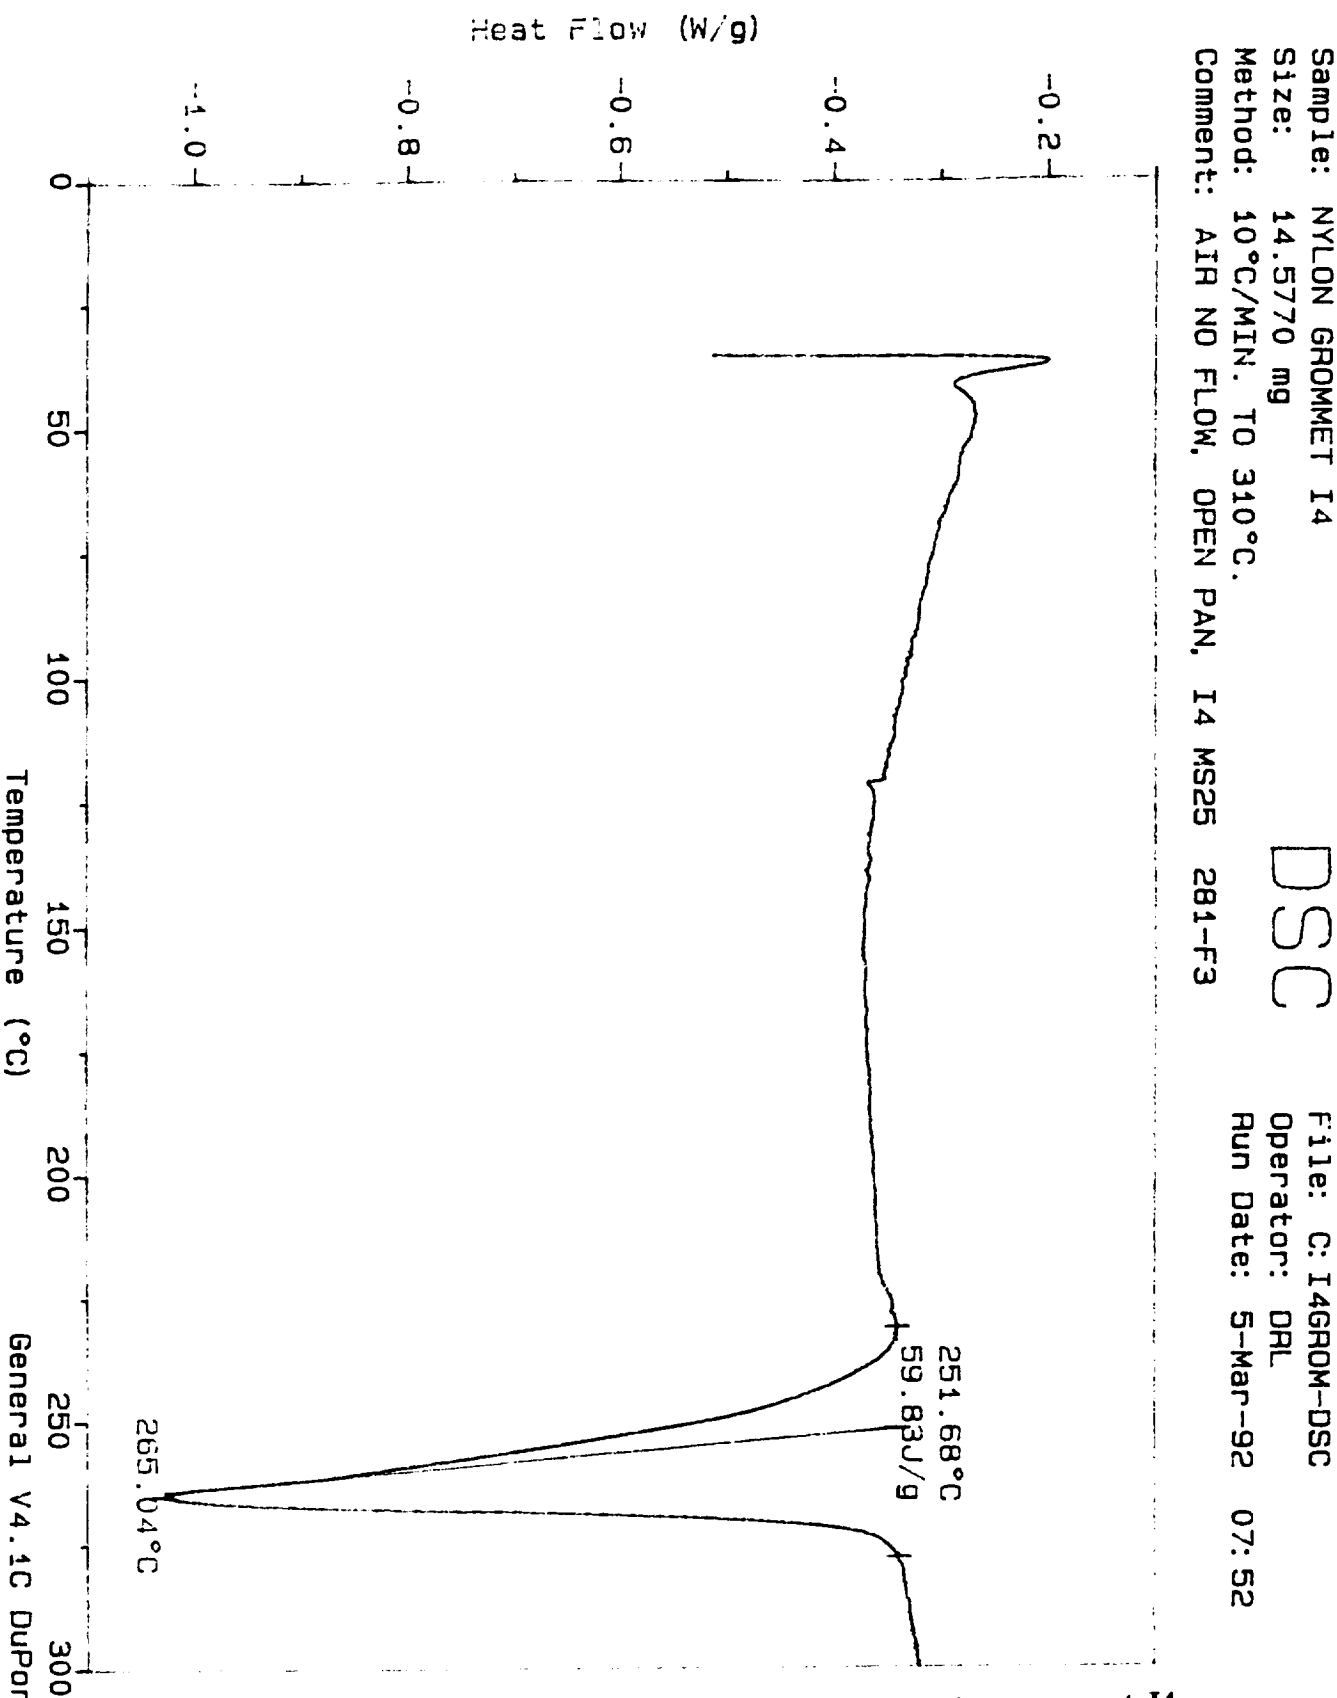
Figure 18. DSC measurement on wire harness bundle nylon grommet I4.

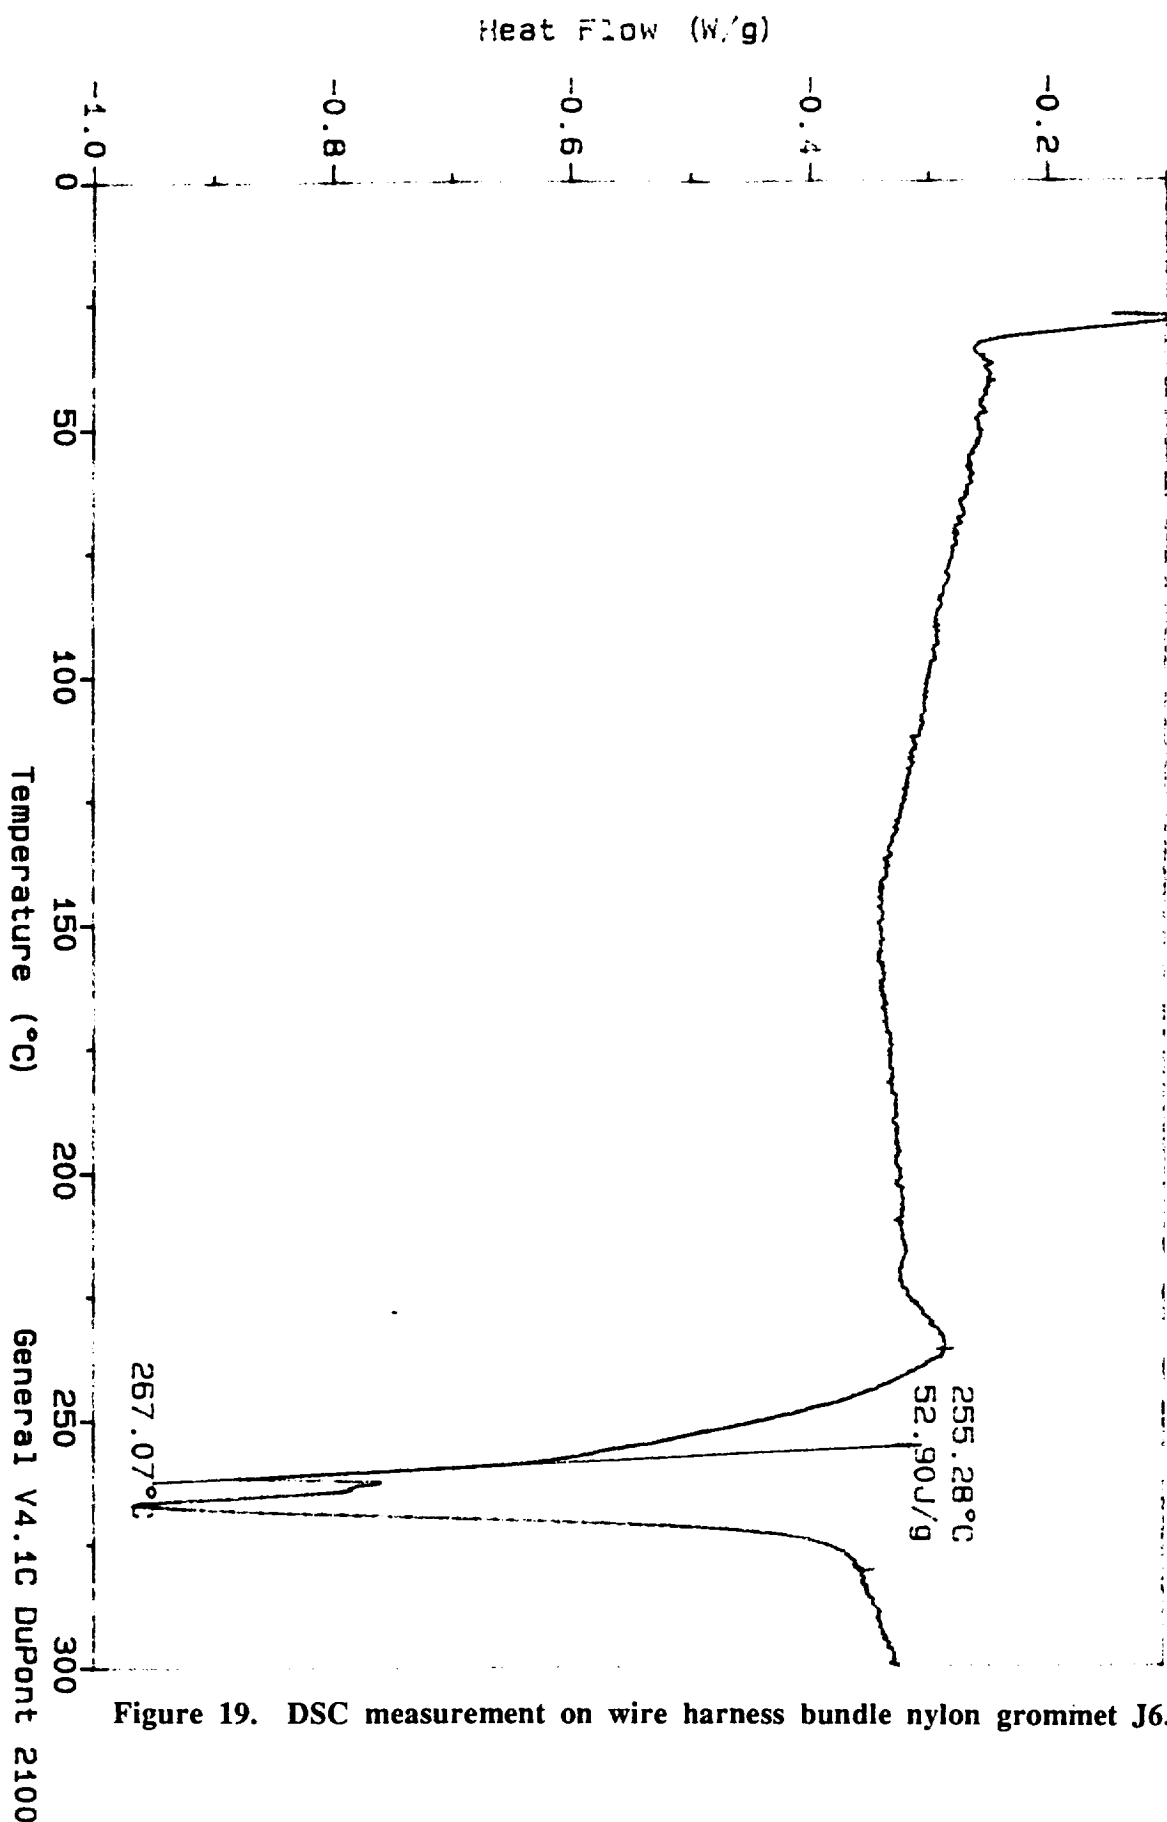
Figure 19. DSC measurement on wire harness bundle nylon grommet J6.

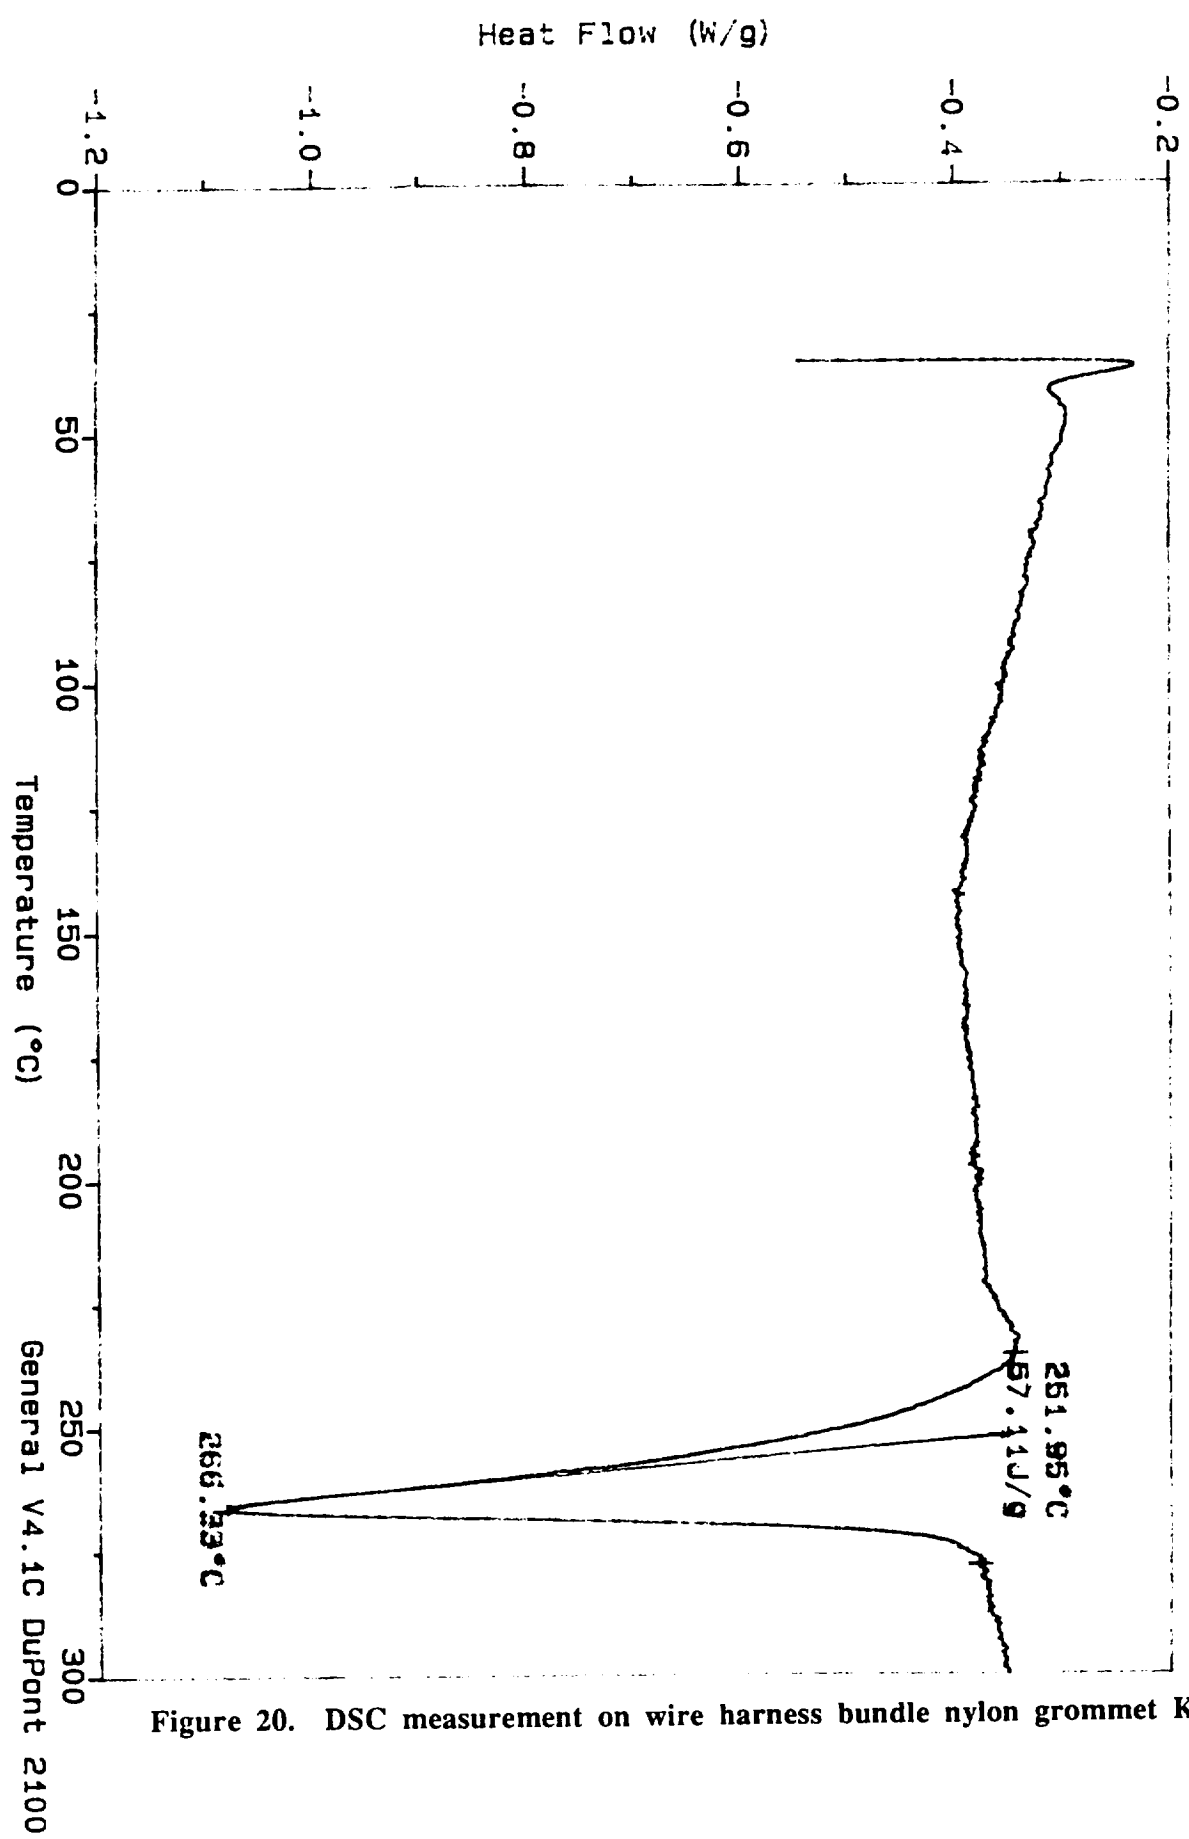
Figure 20. DSC measurement on wire harness bundle nylon grommet K4.

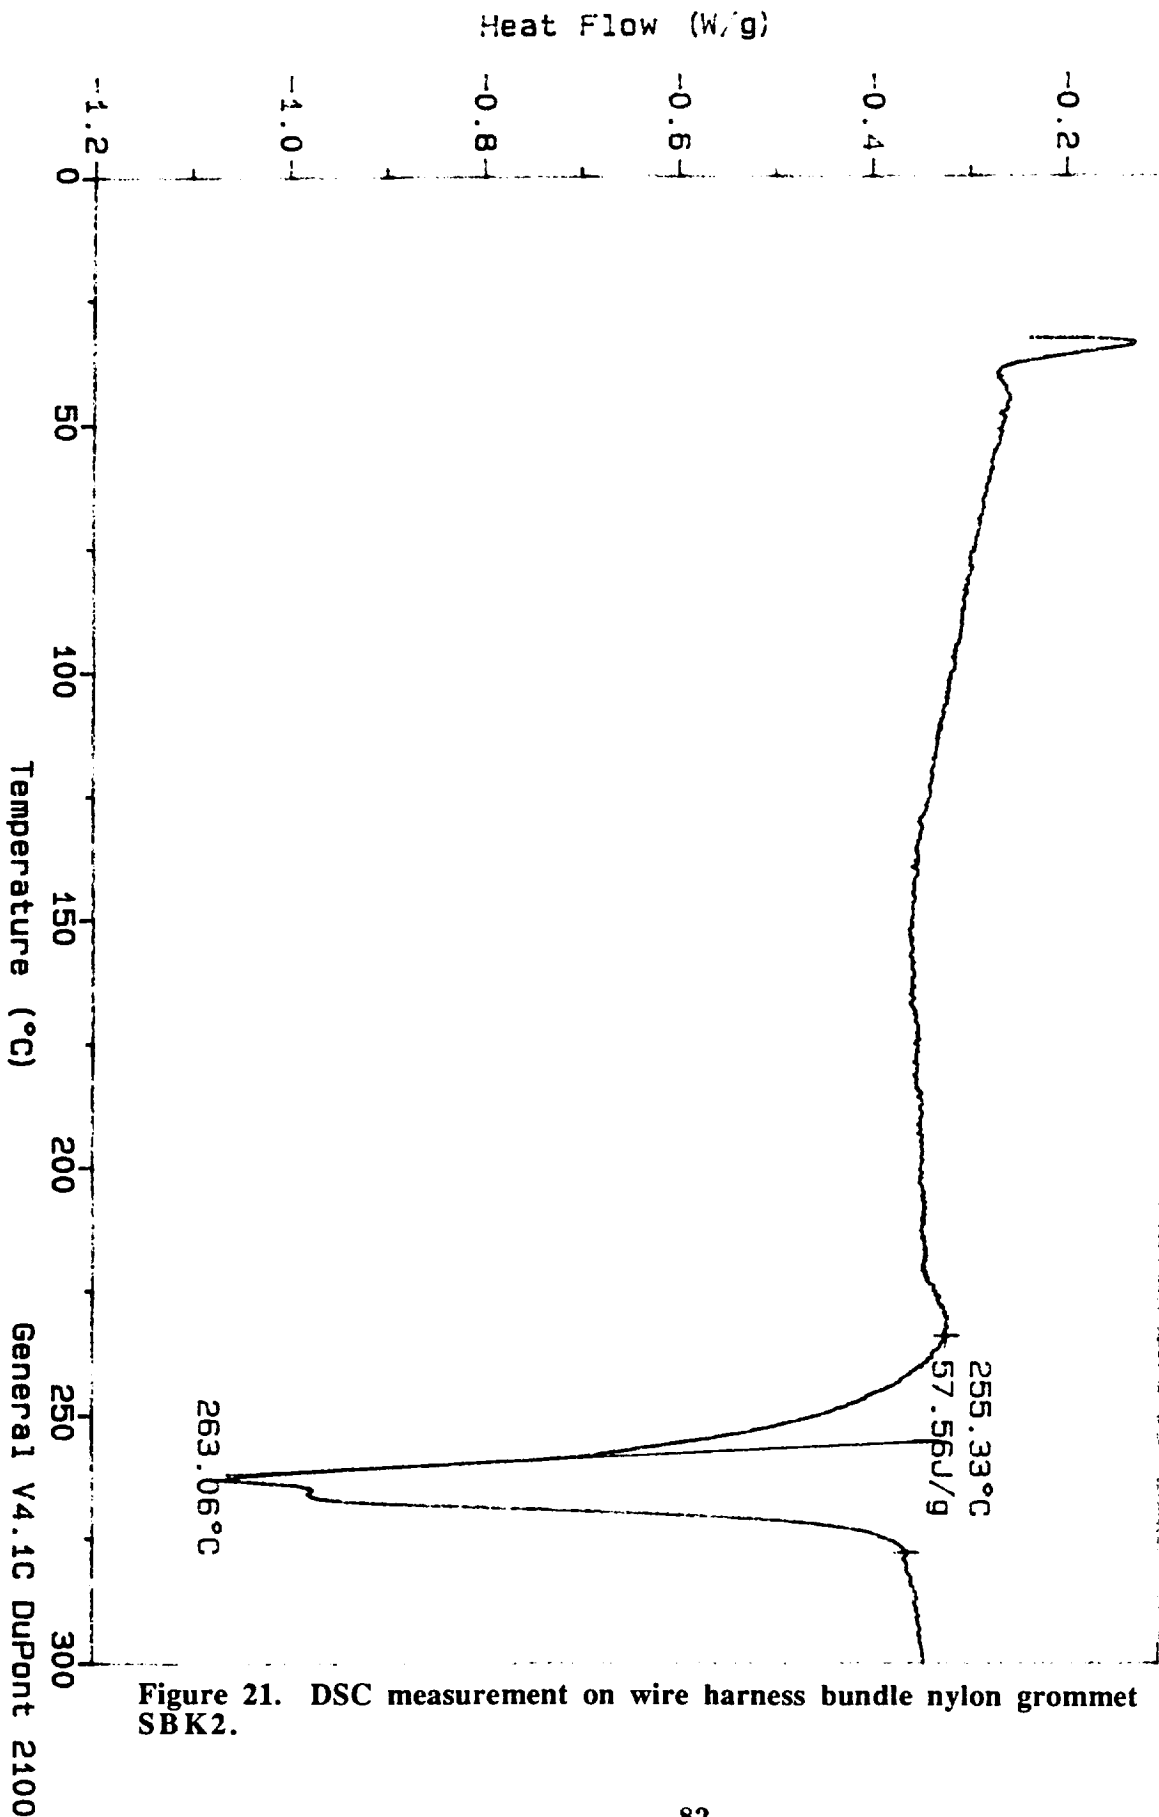
Figure 21. DSC measurement on wire harness bundle nylon grommet SBK2.

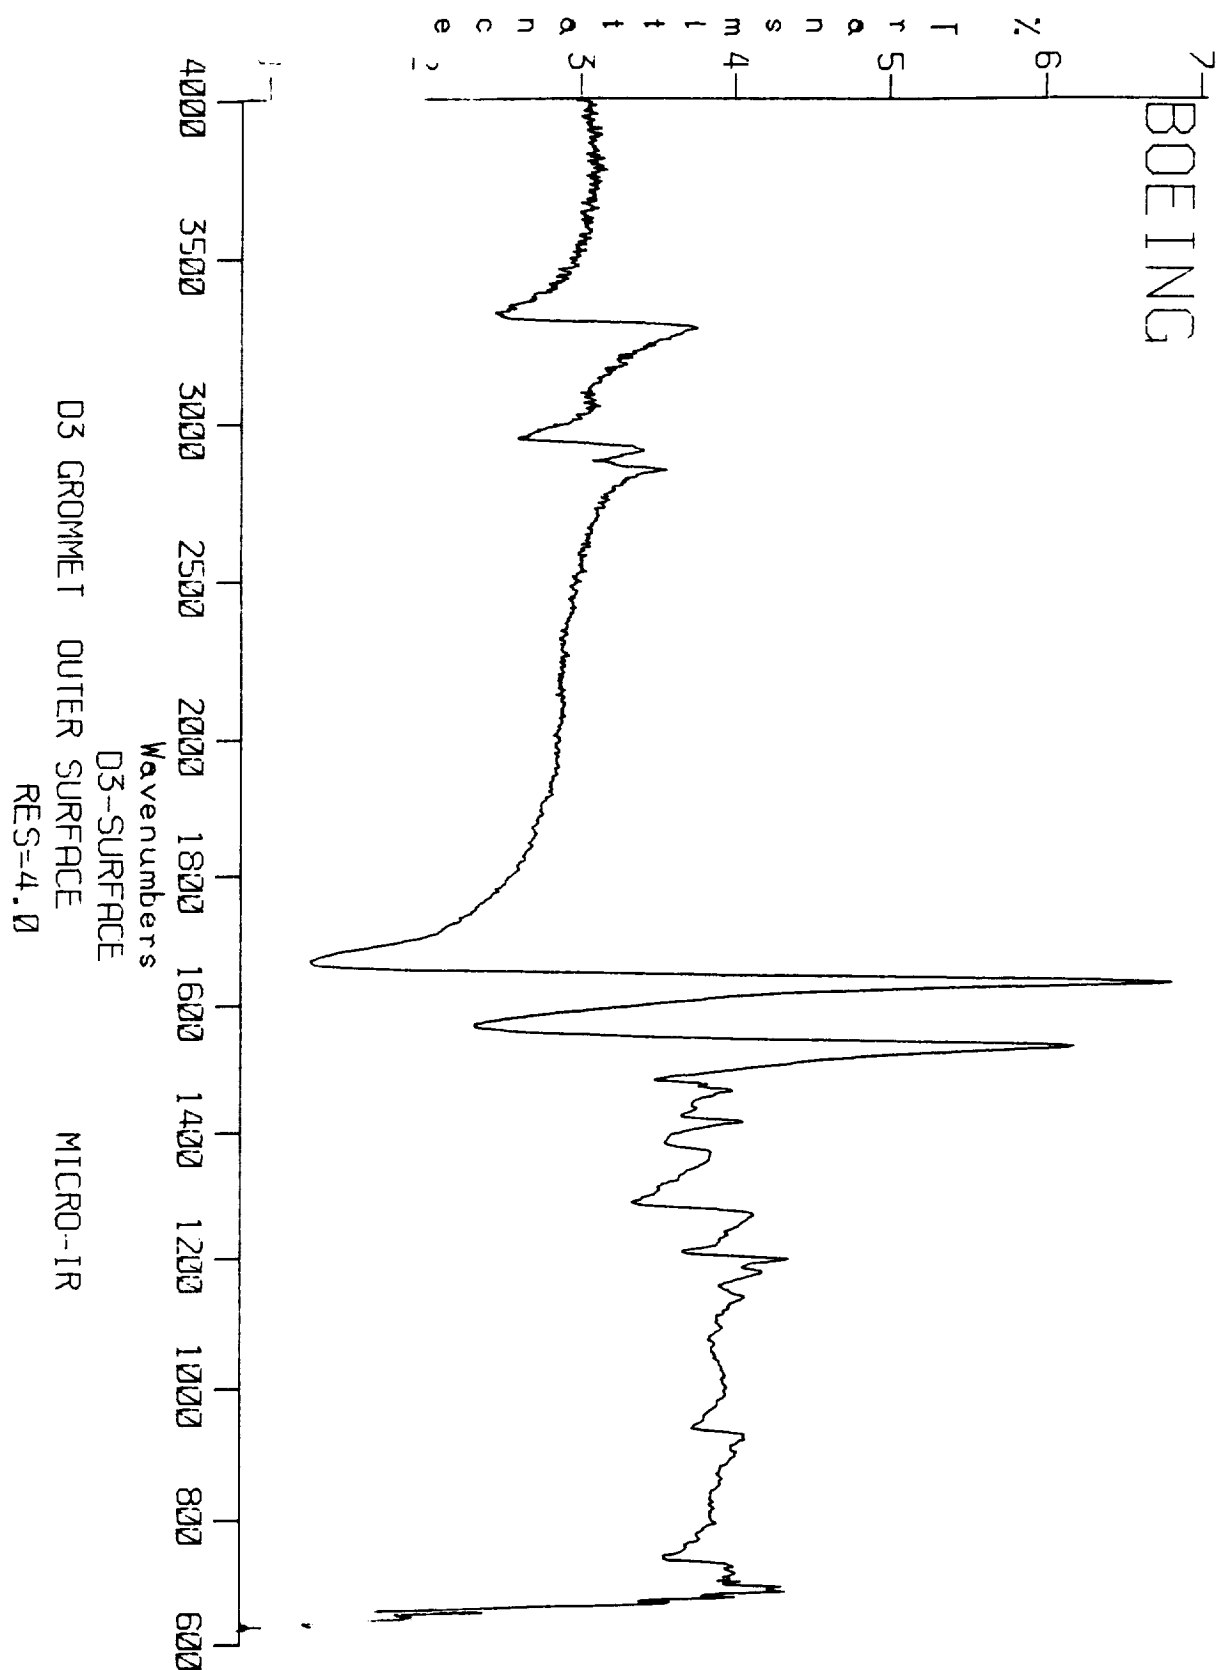
Figure 23. IR transmission spectrum of surface of wire harness bundle nylon grommet D3.
